SPRING / SUMMER 2019

LEVERAGING FITNESS-FOR-SERVICE AND INSPECTION
TECHNIQUES TO MANAGE THE RISKS ASSOCIATED WITH
HIGH-TEMPERATURE HYDROGEN ATTACK

E²G | The
Equity
Engineering
Group, Inc.

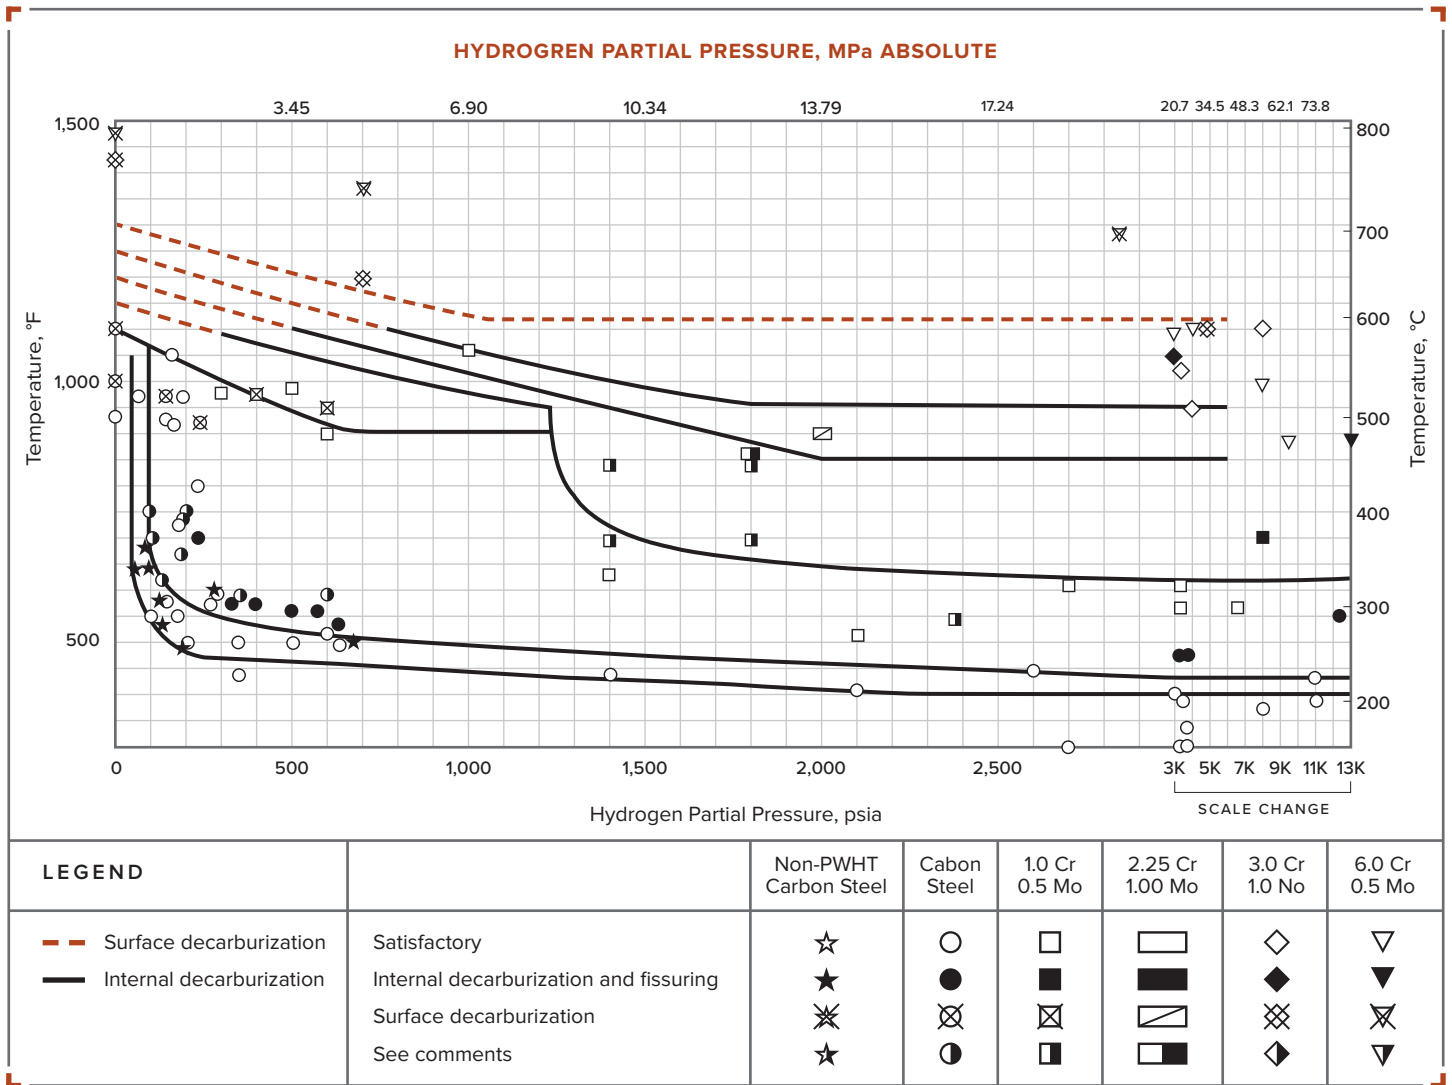
The original set of HTHA resistance curves published by API is based on operating experience and data gathered primarily during the 1940s. These resistance curves, also known as the *Nelson Curves*, are ultimately based on data originally published by G.A. Nelson in 1949 [5]. Other early publications on HTHA include References [6-8]. The Nelson Curves graphically represent *safe* operating zones for common pressure vessel and piping materials of construction, as related to operating temperatures and hydrogen partial pressures. The regions of acceptable or *safe* operation are considered to be below the Nelson Curves. Furthermore, most equipment owner-users typically assign a safety margin (as recommended in API 941 [3]) to achieve operating conditions that are a specified distance below the curve for a given material. The current version of the Nelson Curves from the Eighth Edition of API 941 [3] are shown in Figure 1.

Figure 1. Operating Limits for Steels in Hydrogen Service to Avoid HTHA [3]

Supporting data for the Nelson Curves is overlaid in Figure 1. These data points include successful operation, decarburization (internal and surface) cracking and fissuring, and failures. The dotted lines at the top of Figure 1 reflect the propensity for surface decarburization of steels while they are in contact with hydrogen. The solid lines represent the propensity for steels to decarburize internally with resultant fissuring and cracking. Furthermore, these points were obtained from a variety of commercial processes and laboratory experiments. The combination of elevated temperature and low hydrogen partial pressure generally favors surface decarburization, without internal decarburization and fissuring. In contrast, the combination of low temperature, but above 400°F (204°C), and high hydrogen partial pressure, above 2200 psia (15.17 MPa), typically favors internal decarburization and fissuring, which can eventually lead to the initiation and propagation of crack-like flaws. At elevated temperatures and high hydrogen partial pressures, both damage mechanisms may be active [3].

In general, C-0.5Mo steels vary significantly in their resistance to HTHA. In fact, some heats seem to have HTHA resistance only marginally better than carbon steel. Furthermore, the current edition of API 941 [3] indicates existing C-0.5Mo steel equipment that is operated above the PWHT carbon steel curve

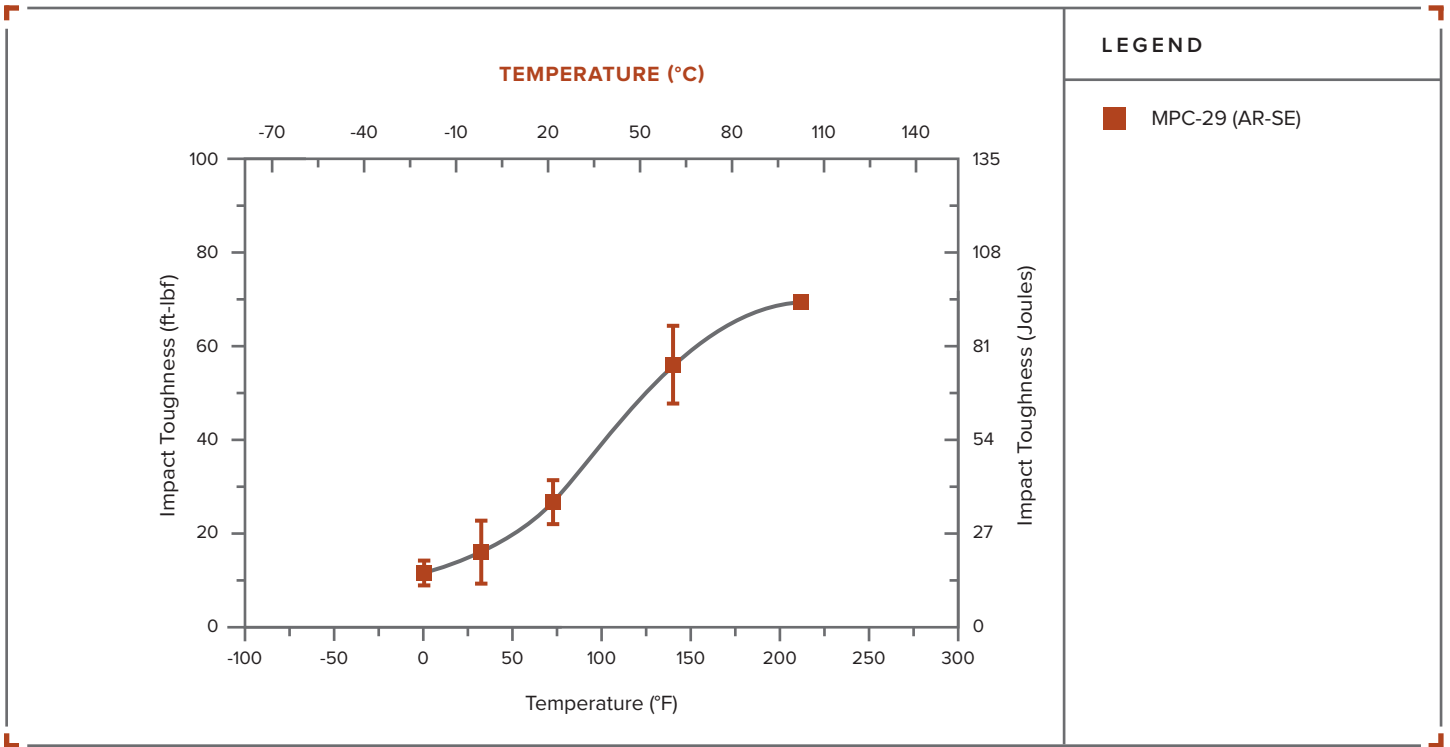
Welding Research Council (WRC) Bulletin 548 [4] provides information on the mechanical properties of different C-0.5Mo samples exposed to different heat treatments and after high-temperature hydrogen service exposure. An example of impact energy for a service-exposed C-0.5Mo sample as a function of temperature is shown in Figure 3. This figure shows that upper shelf fracture toughness is likely not achieved until a temperature of 200°F or higher is reached.

^ Figure 3. Impact Energy vs. Temperature for Service-Exposed C-0.5Mo [4]

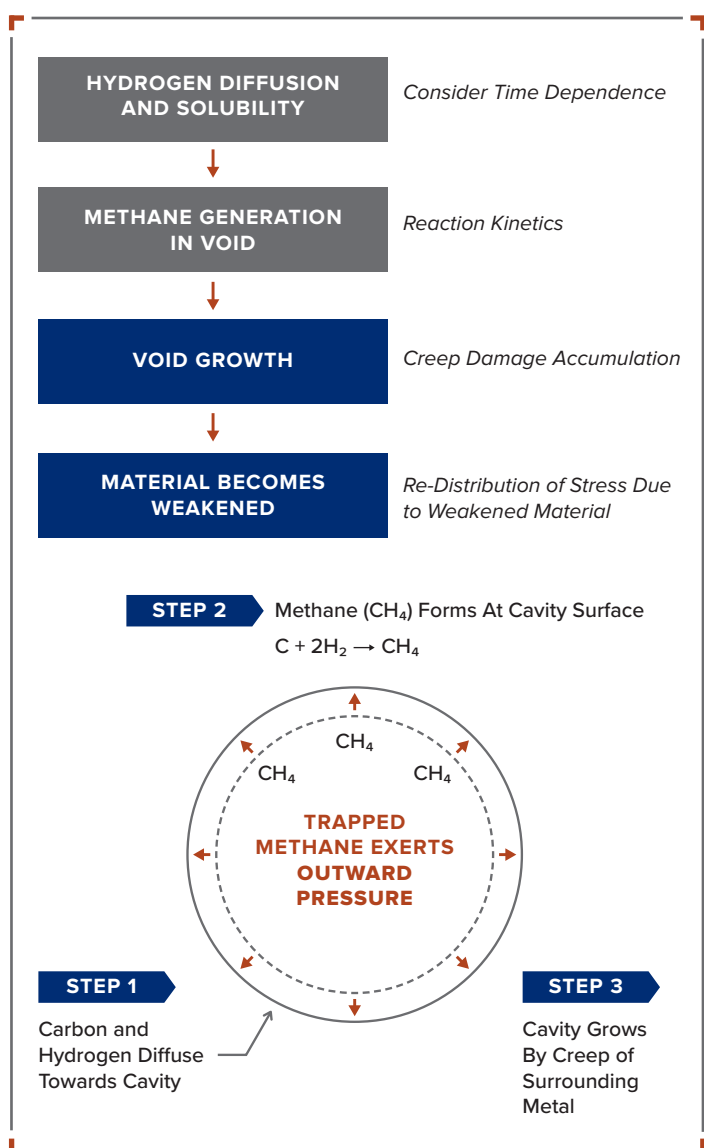
As discussed extensively in References [9-11], the mechanism of HTHA is characterized by volumetric material damage and possibly, the propagation of crack-like flaws (typically at or near welds). Figure 5 shows a schematic of how material can become weakened over time due to the mechanism of HTHA. In summary, damage starts through the diffusion of hydrogen into steel, where it chemically reacts with free carbon at high temperatures to produce methane. This methane then gets trapped inside small cavities and other material defects. Over time, the rising methane pressure in these cavities can cause damage at the material grain boundaries. Furthermore, long-term exposure to high-temperature hydrogen environments can lead to volumetric damage that can diminish the load-carrying capability of pressure equipment and accelerate the propagation of crack-like flaws. Additionally, micro-cracks tend to form at grain boundaries and can coalesce to form macro-cracks.

^ Figure 5. Schematic Showing the Mechanism of HTHA Damage [13]

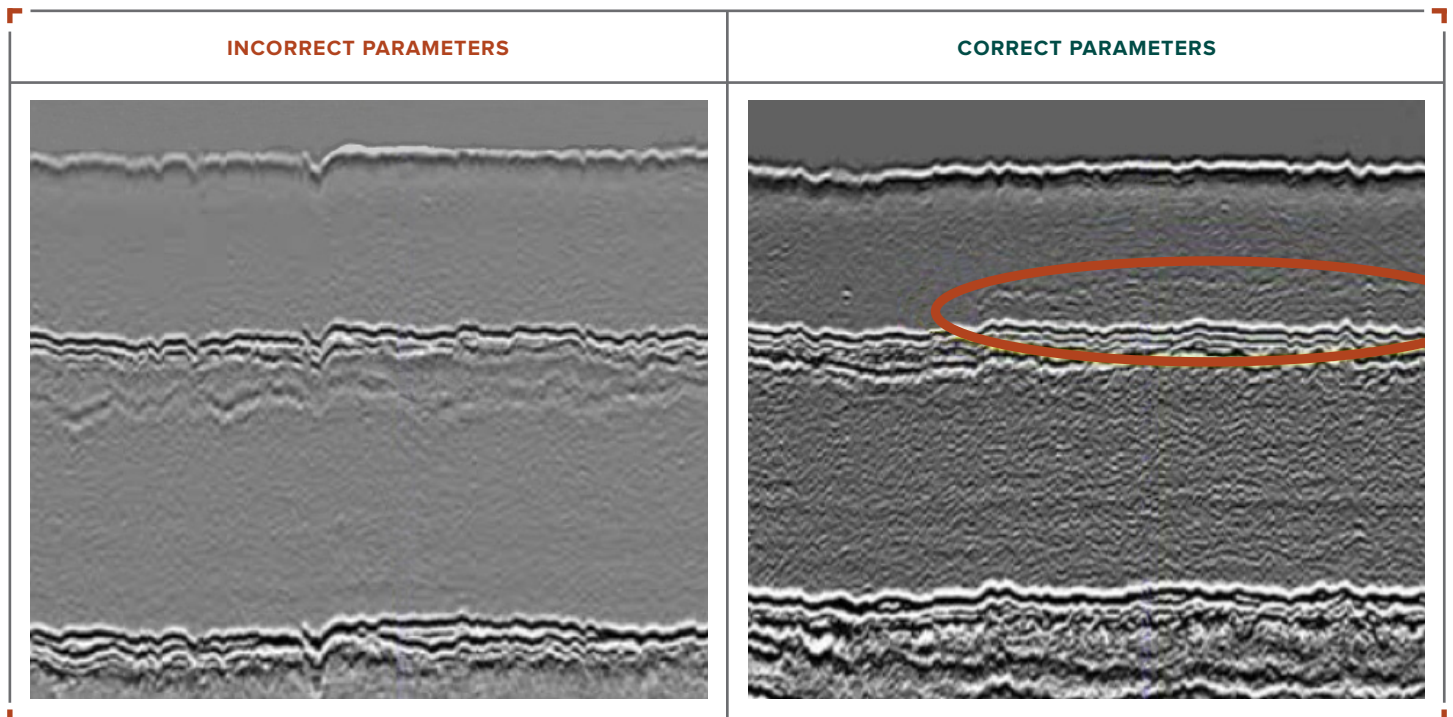
^ **Figure 7.** Weld with No Apparent HTHA Due to Incorrect TOFD Set-Up Parameters (left) and TOFD Scan of the Same Weld with the Correctly Tuned Parameters, Showing HTHA Damage (right) [23]

The advantage of TOFD is the data acquisition speed over other computerized ultrasonic inspection systems, the benefit of which principally allows rapid screening of welds and HAZs to identify potential areas of HTHA. Detection of HTHA using TOFD requires careful consideration pertaining to inspection parameters, including transducers, filters, and contrast palette. Failure to optimize these parameters can result in missing early stage HTHA damage [23]. To highlight this point, Figure 7 shows two TOFD scans of a weld with HTHA damage. One scan has incorrect set-up parameters (thus showing no apparent damage) and the other has the correct parameters (clearly showing HTHA damage). If HTHA damage is identified using TOFD, follow-up targeted PAUT is often warranted to further characterize the severity and extent of the damage. Again, proper tuning of parameters is imperative.

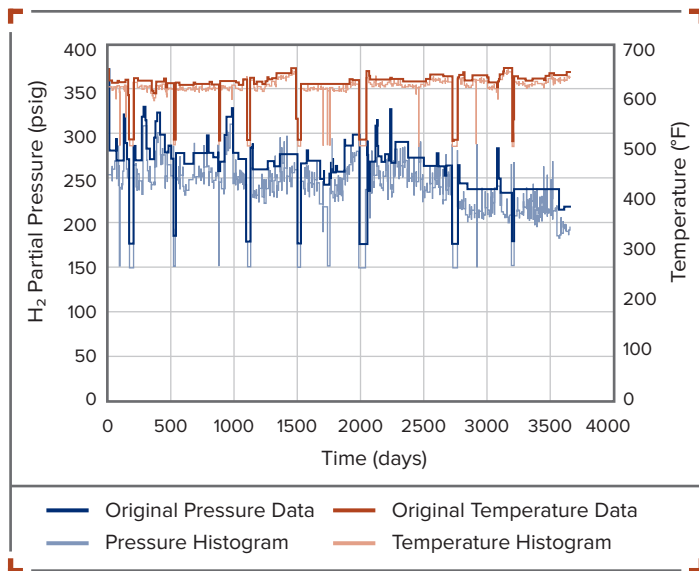
Based on this approach, the resulting pressure and temperature histograms are plotted in Figure 9 (note there is a primary and secondary axis). This 10-year window of available operating conditions is then extrapolated and assumed to be applicable for the entire lifetime of the reactor to-date (since 1975). To offer additional perspective on typical historical operating conditions, operating data points are overlaid onto the current as-welded and PWHT carbon steel Nelson Curves (with the latter being the current recommended limit for C-0.5Mo) in Figure 10. This figure demonstrates that historical operating trends for the reactor in question generally fall above the PWHT carbon steel curve, highlighting the potential for HTHA damage.

Figure 9. Histograms of Hydrogen Partial Pressure and Temperature Data

Using the established hydrogen partial pressure and temperature histograms shown in Figure 9, HTHA damage calculations are carried out based on the E²G JIP [9-11]. Additionally, two different future operating temperatures are considered: 625°F and 650°F. For both assumed temperatures, crack growth calculations are performed based on different flaw sizes. These crack growth calculations are based on data published by Shewmon and Xue [25] with factors of safety applied. It is recognized that this crack growth data is based on carbon steel base metal. Nevertheless, this baseline data is leveraged until ongoing crack testing results that include welds and C-0.5Mo samples (as part of the ongoing JIP [9-11]) become available. The concept of these crack growth estimates is to determine if a current crack-like flaw is likely to propagate to critical dimensions (determined using the fracture mechanics approach described below) before planned reactor replacement. To this end, reactor replacement is the recommended long-term strategy given the vintage of the reactor and the identified potential HTHA damage. Nevertheless, in the short-term, risk mitigation strategies including establishing technically based pressurization

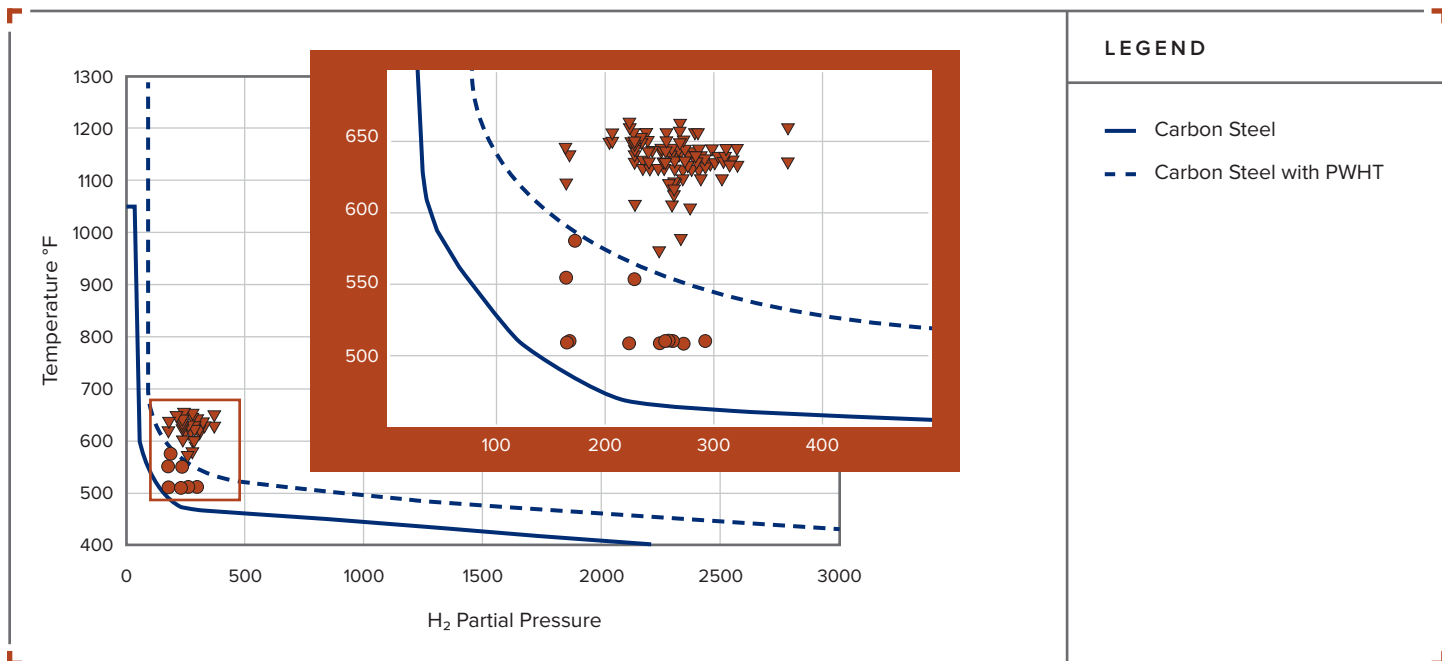
Figure 10. Operating Hydrogen Partial Pressure and Temperature Data Overlaid on Nelson Curves

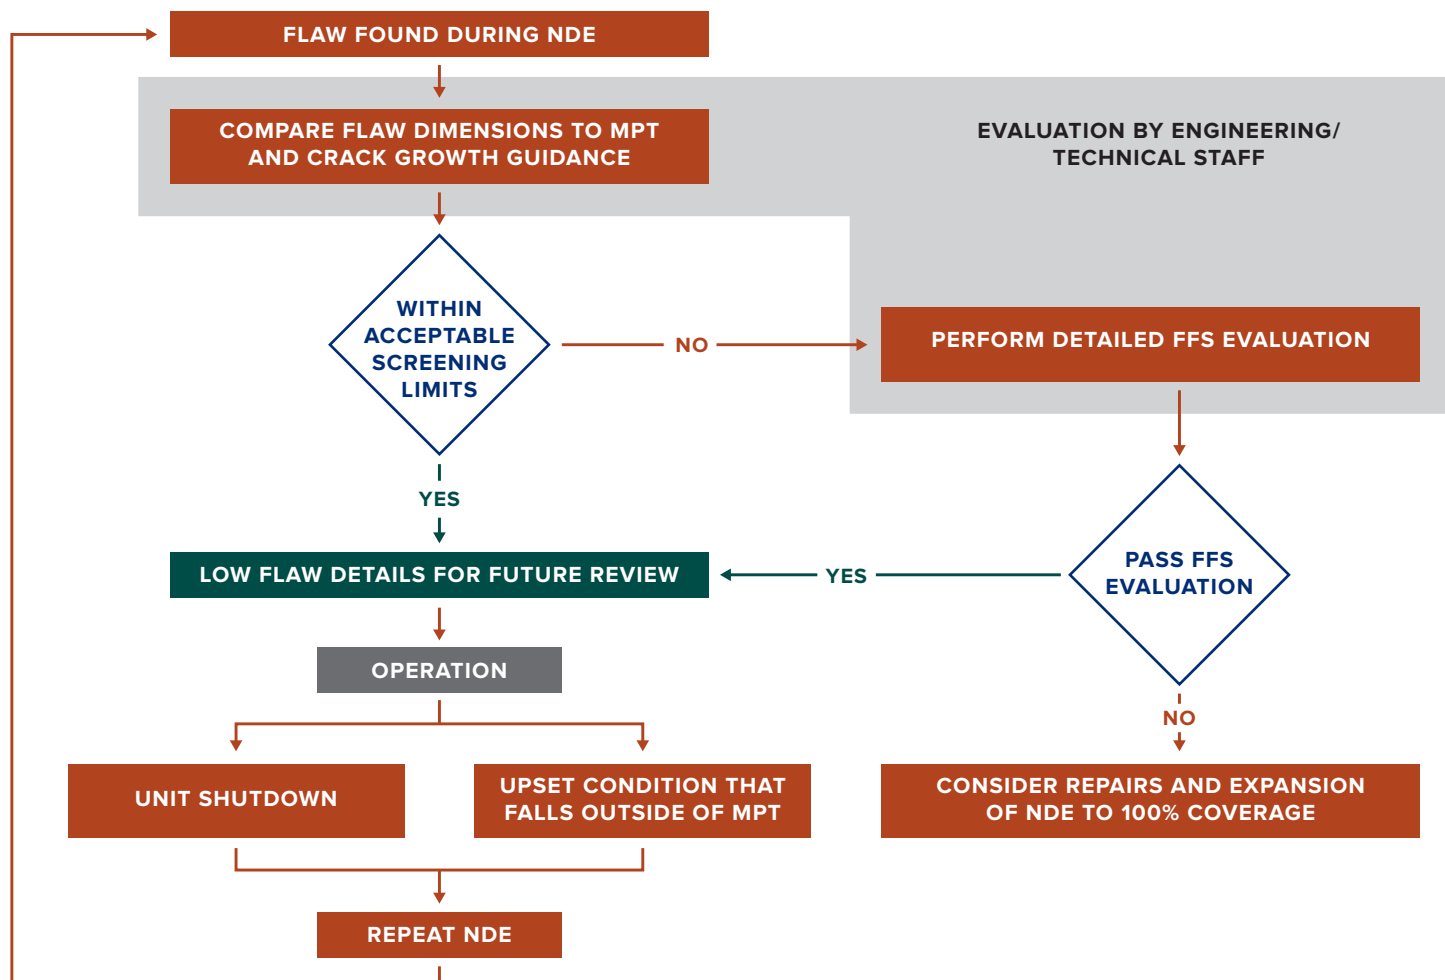
The flow chart shown in Figure 11 summarizes, from a high level, the overall approach for attempting to qualify the fitness-for-service of the hydrotreater reactor with potential HTHA damage. This figure demonstrates the interaction between inspection findings and performing advanced analysis (such as MPT and crack growth calculations) to qualify the identified damage. Additionally, the overall process for maintaining safe operation is outlined. Violating the recommended MPT envelopes (possible upset scenario) or shutting down results in the recommendation for follow-up inspection to quantify damage progression.

^ Figure 11. Flow Chart of Fitness-For-Service Analysis Approach

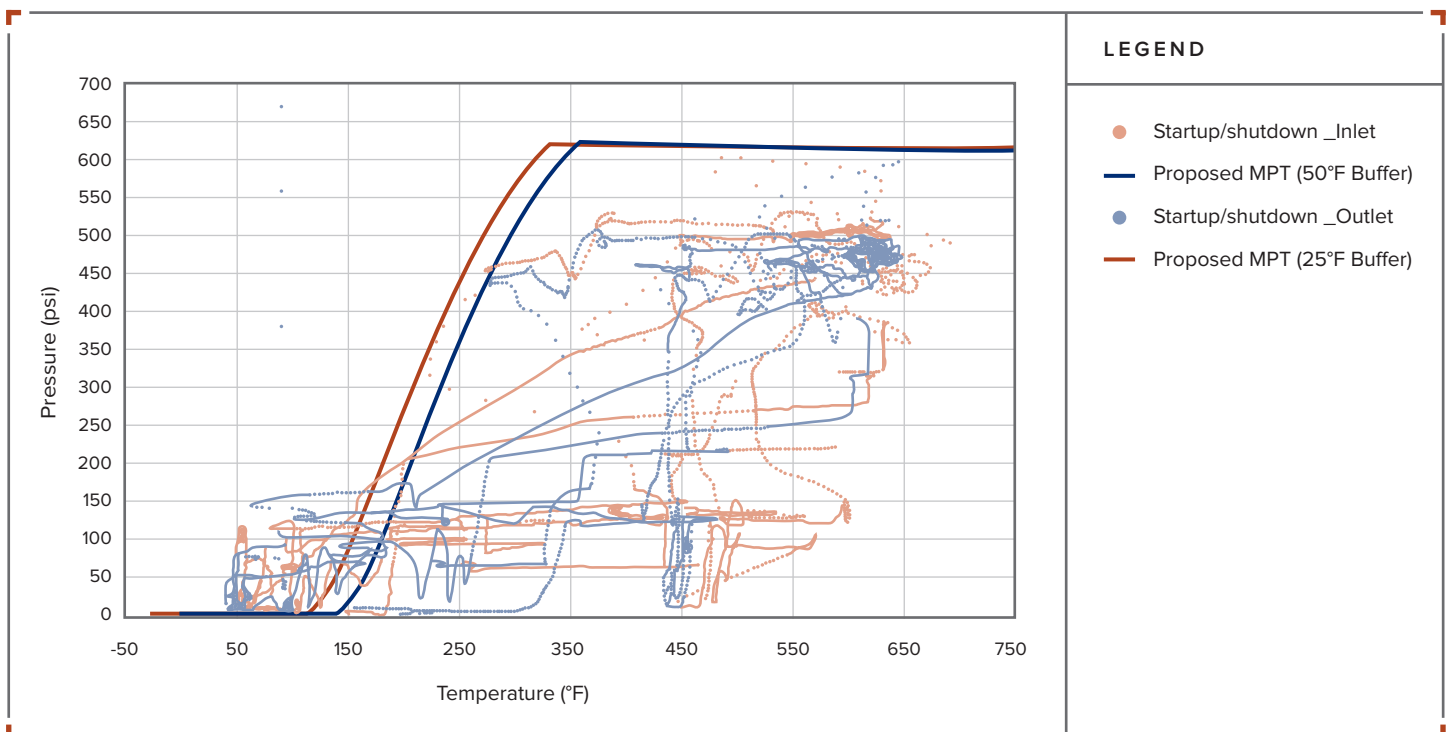
Given limiting pressurization recommendations and the identification of damage indicative of HTHA, the long-term strategy for the hydrotreater reactor in question is replacement; however, there is an approximately two-year operating window before this replacement is feasible. To manage the overall risk in the short-term, modified pressurization procedures are necessary. As a practical means to achieve reactor metal temperatures of approximately 200°F before pressurization, external steam tracing was applied to the reactor pressure boundary. Once this metal temperature is achieved, the intent is to keep operating (pressure-temperature) points within the proposed MPT curve with a 50°F buffer.

Figure 12. Proposed MPT Envelopes with 25°F and 50°F Buffers Relative to the Most Limiting Crack-Like-Flaw

In this case, external steam tracing was installed on the reactor to achieve a bulk pressure boundary metal temperature of 200°F prior to reactor pressurization to avoid brittle fracture, and the proposed MPT envelope with a 50°F shift or buffer relative to

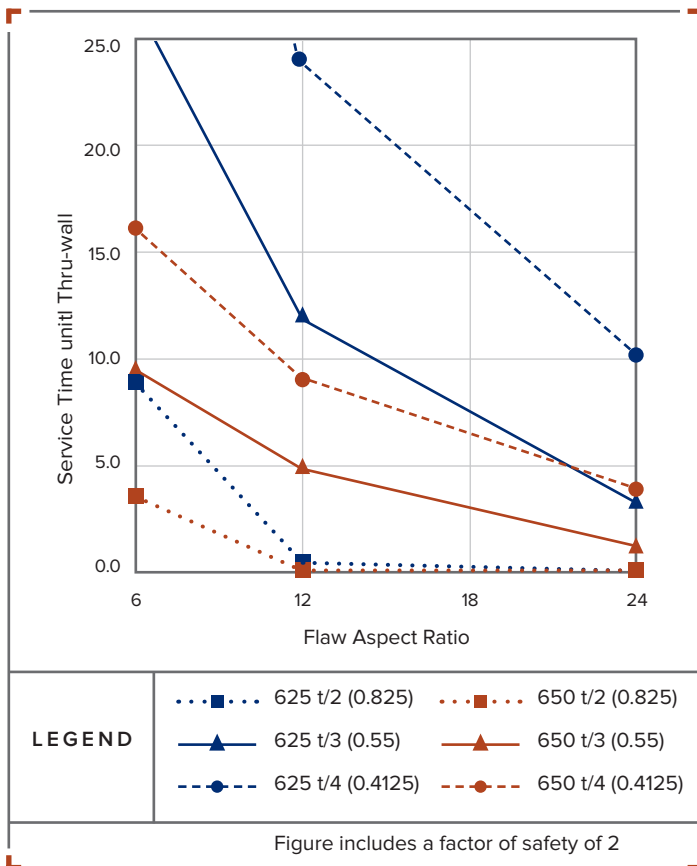
some of the reactor pressure boundary welds, crack-growth estimates are carried out for different flaw depths with different aspect ratios (length-to-depth ratios). Figure 13 shows operating time (in years) for a given crack-like flaw ($t/4$, $t/3$, and $t/2$), in the cylindrical shell remote from structural discontinuities, to reach critical dimensions or reach 80% through-wall based on the crack growth correlations in Reference [25]. This figure includes a safety factor of two on all points since the baseline crack growth data from Reference [25] is for base metal only and not welds (where residual stresses, material property mismatches, and geometric effects could accelerate crack growth). Furthermore, along the horizontal axis of Figure 13, sensitivities to different flaw length-to-depth aspect ratios are evaluated (from 6:1 up to 24:1). As expected, longer crack-like flaws have a shorter predicted remaining life. Additionally, this figure shows predictions for future operating temperatures of 625°F (blue curves) and 650°F (orange curves). Again, as expected, the higher future operating temperature results in more rapid crack growth rates. It is noted that inspection intervals of half the predicted remaining life (or less) are generally recommended as well.

Figure 13. Predicted Crack Growth Rates in the Cylindrical Shell
